# Gold Mining in Prey Lang Wildlife Sanctuary, Cambodia

Evolution from Small-Scale Artisanal to Large-Scale Commercial  
&  
Its Environmental and Human Impacts

Researched and written by: Prey Lang Gold Mining Investigation Team

October 2023

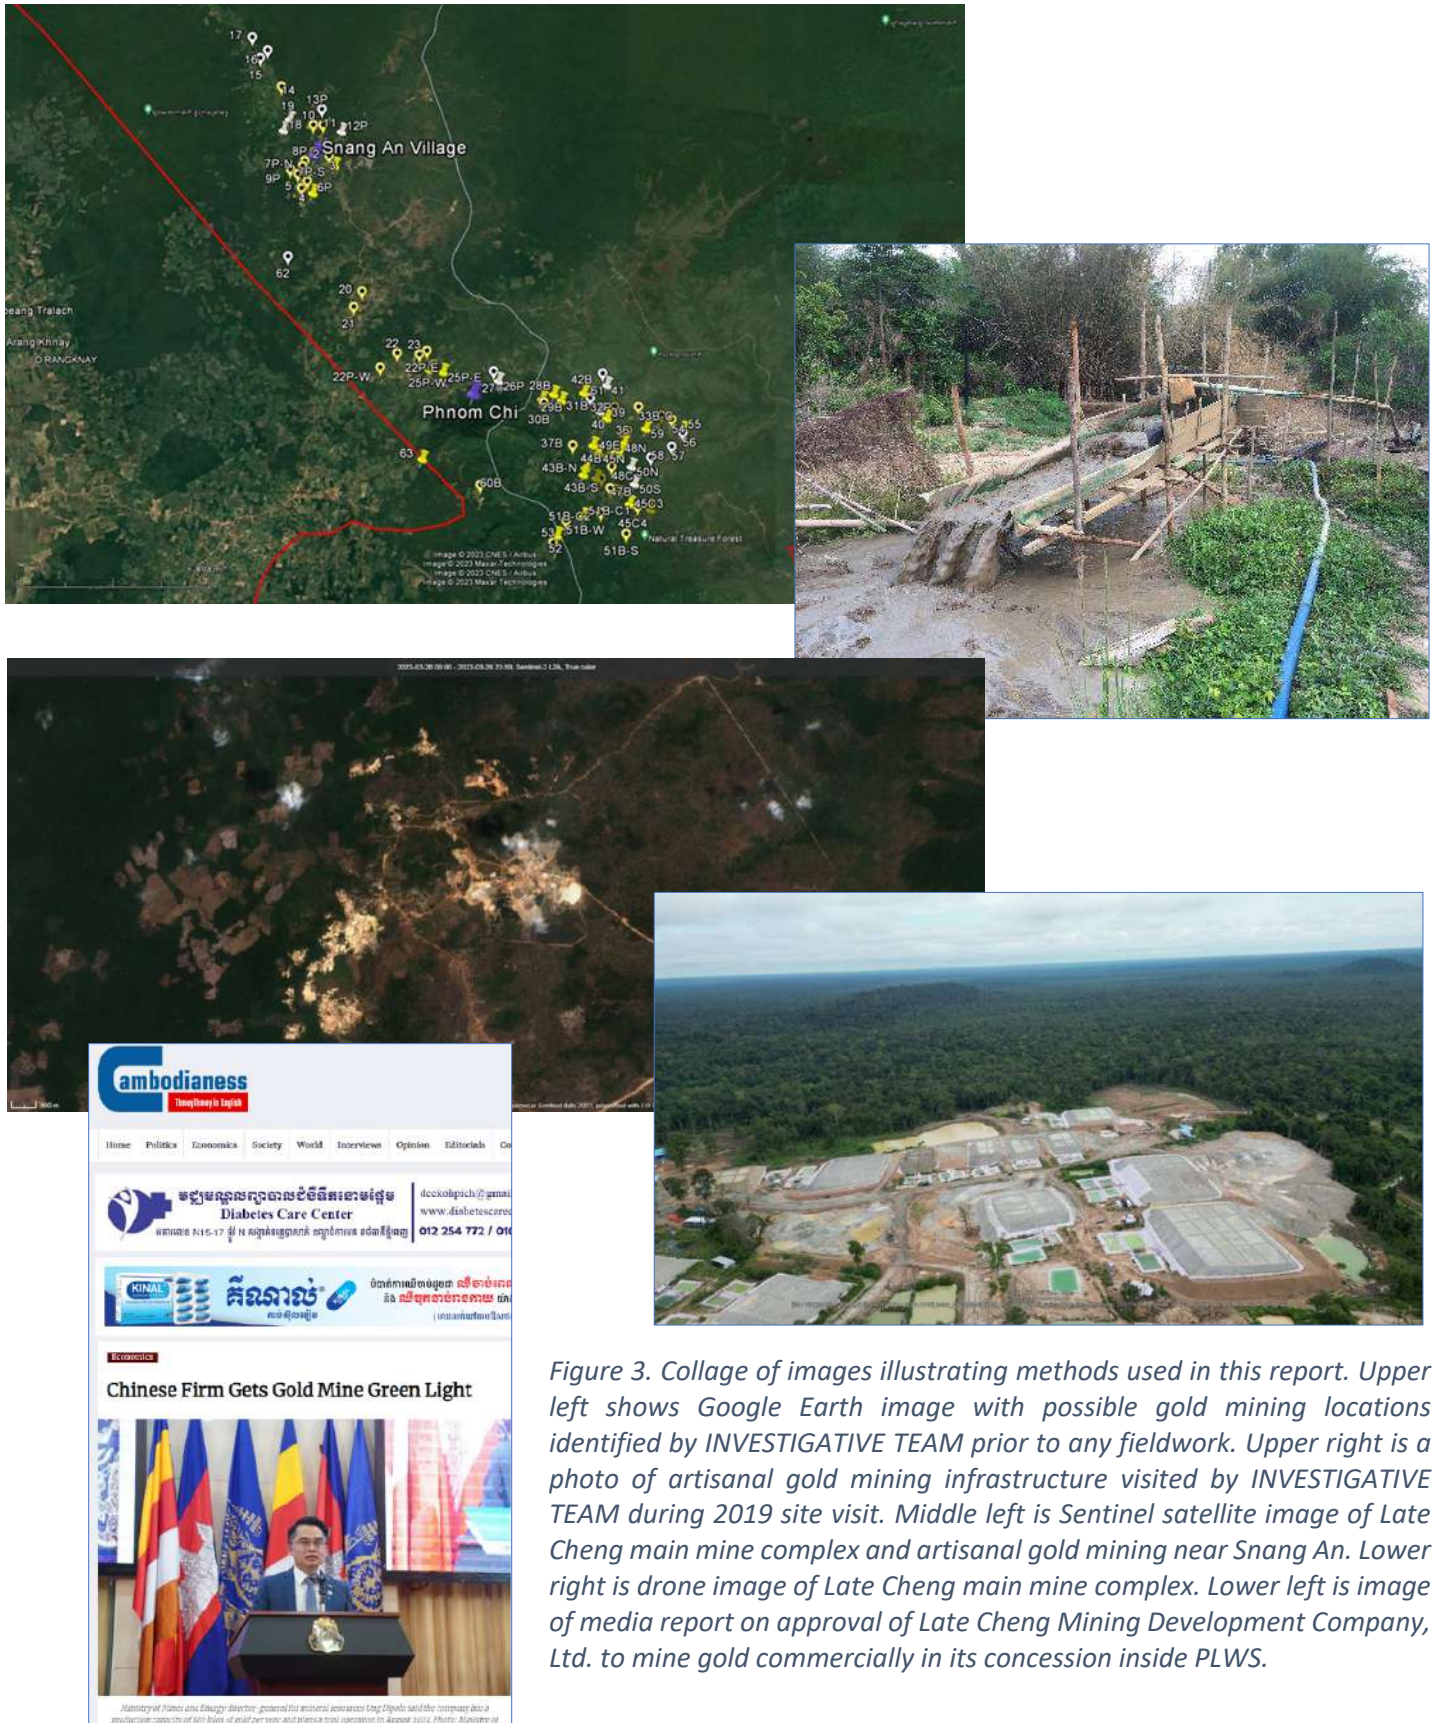
Figure 3. Collage of images illustrating methods used in this report. Upper left shows Google Earth image with possible gold mining locations identified by INVESTIGATIVE TEAM prior to any fieldwork. Upper right is a photo of artisanal gold mining infrastructure visited by INVESTIGATIVE TEAM during 2019 site visit. Middle left is Sentinel satellite image of Late Cheng main mine complex and artisanal gold mining near Snang An. Lower right is drone image of Late Cheng main mine complex. Lower left is image of media report on approval of Late Cheng Mining Development Company, Ltd. to mine gold commercially in its concession inside PLWS.

- *This evolution has been extensively documented by the Prey Lang Gold Mining Investigation Team (Investigation Team or Team) through: (1) an evaluation of readily-available satellite imagery (Google Earth, Sentinel, Planet); (2) ground-truthing of satellite imagery during site visits in 2018 and 2019; (3) further evaluation of satellite imagery plus collection of drone images in 2022-present; and (4) evaluation of Cambodian media reports on gold mining in PLWS (Figure 3). Methods are described in detail in Section 2.*

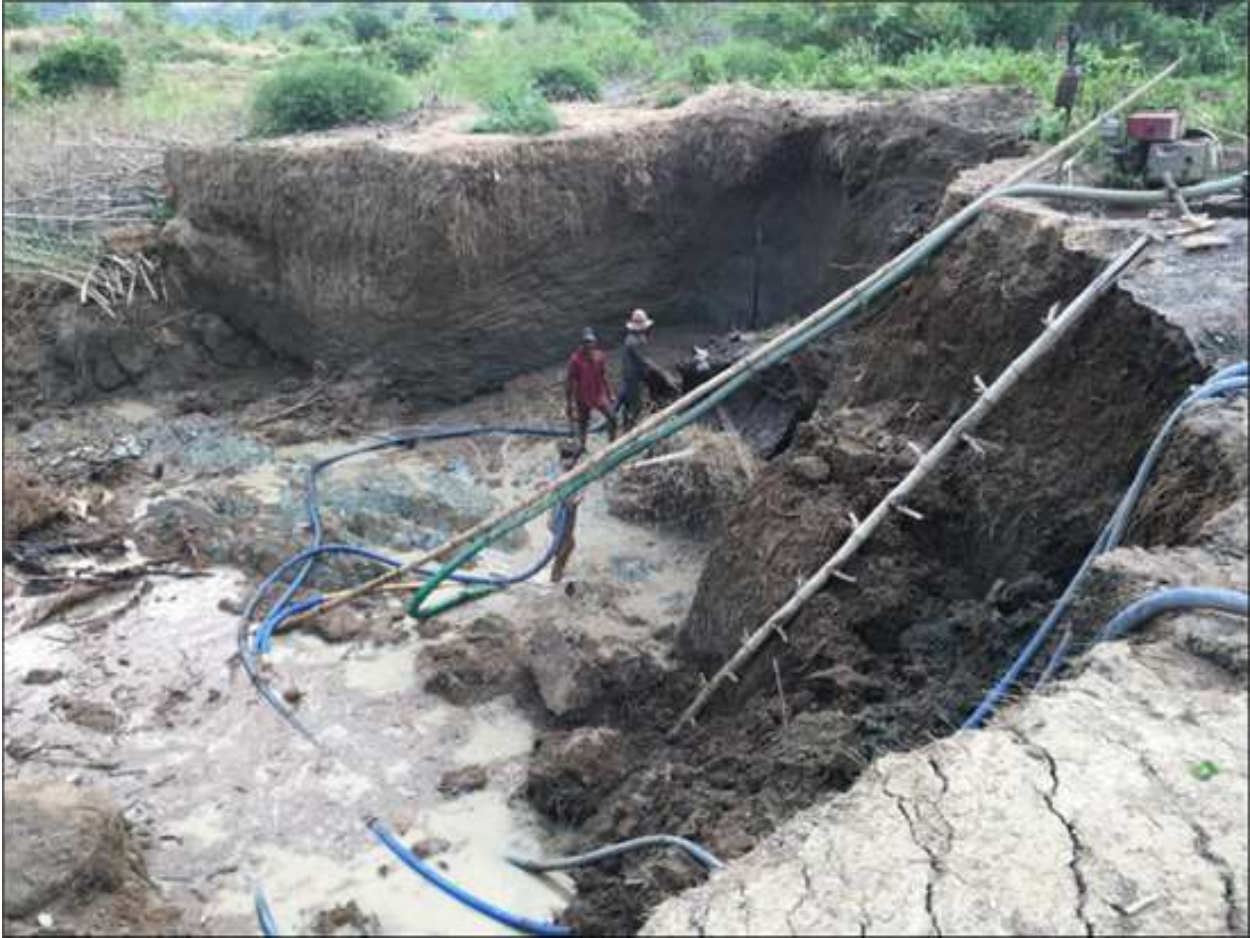
*Figure 4. Photo illustrating artisanal gold mining of alluvial stream deposits using hydraulic (high-pressure jet of water) methods. This stream is located just northwest of Phnom Chi Mountain (shown in Figure 16).*

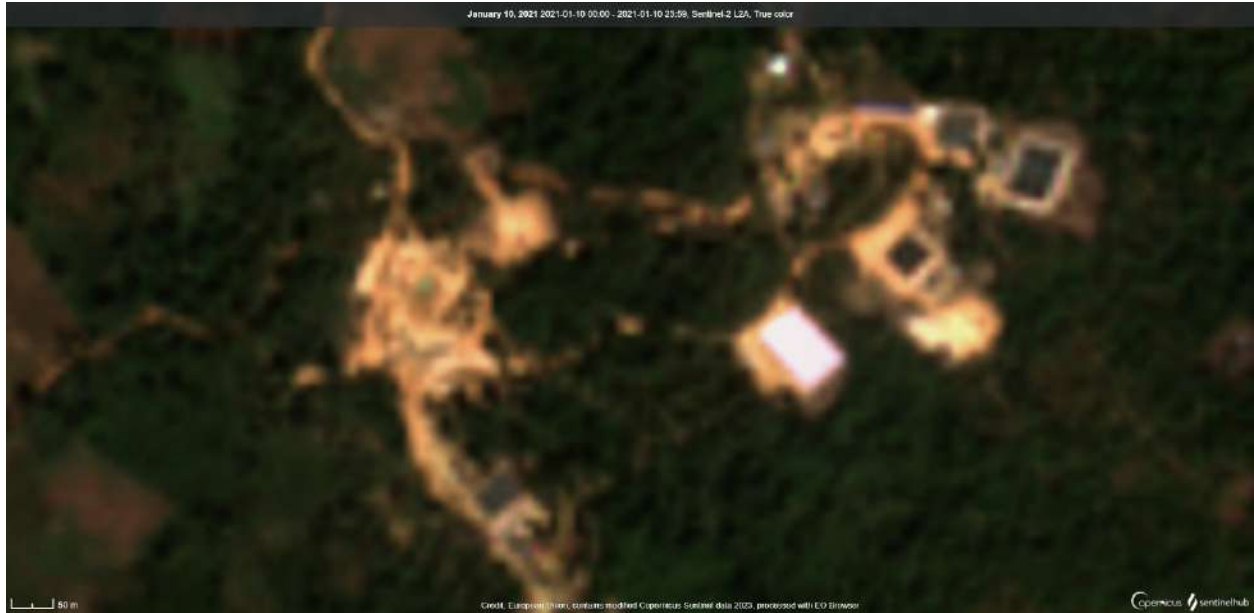
*Figure 8. Sentinel satellite image from January 10, 2021, showing leach fields and wastewater ponds already developed at the main mine complex of the Late Cheng Mining Development Company, Inc.*

- Cyanide is almost certainly being used to separate gold in Late Cheng's main mine complex, based on the presence of leach fields (heaps)/ponds and leach tanks. Cyanide has well known environmental and human health risks that remain undocumented within the Late Cheng concession area. Further documentation of the extent of these impacts is needed, in particular surface and groundwater contamination and exposure of mine workers and their families.

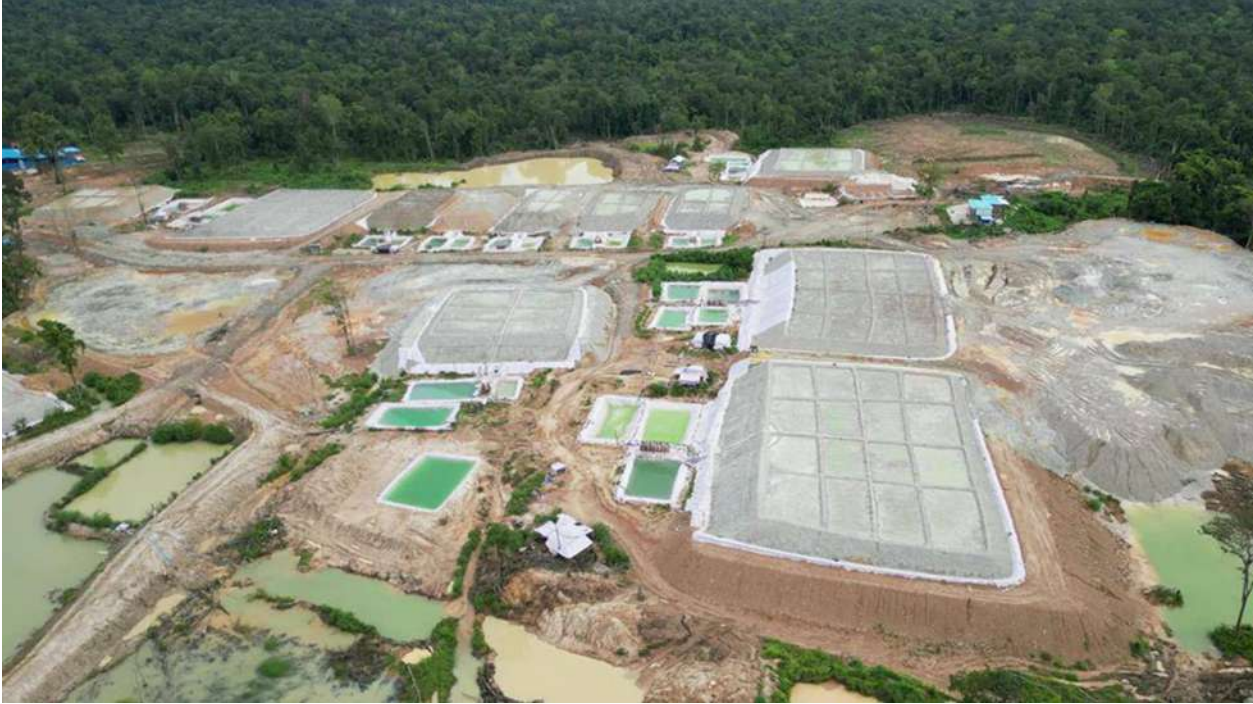
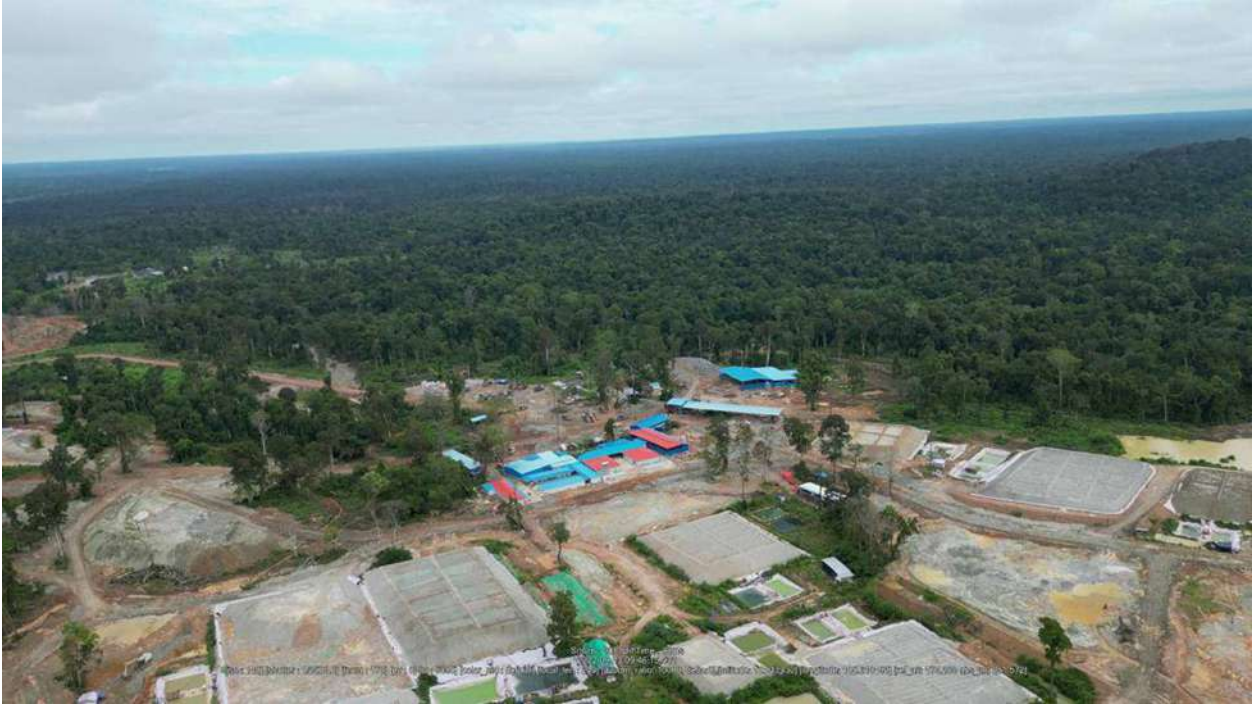
Figure 9b (top and bottom). Drone imagery of Late Cheng main mine complex (Autumn 2022).

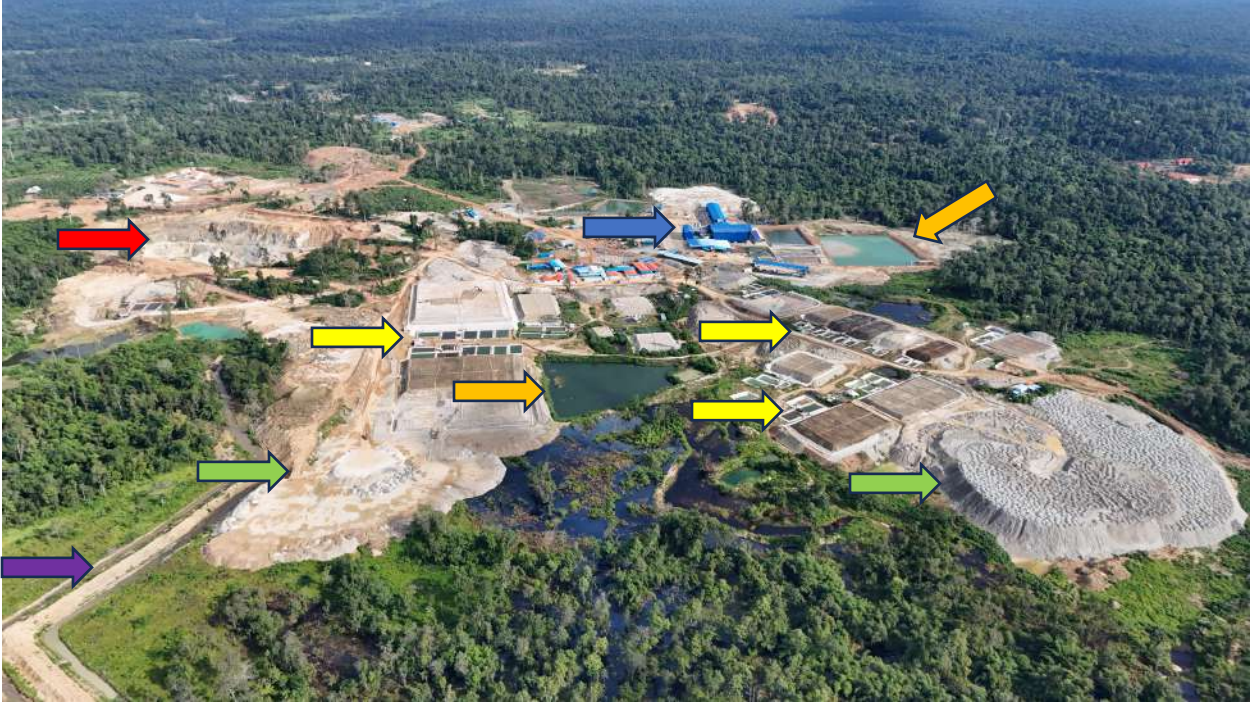
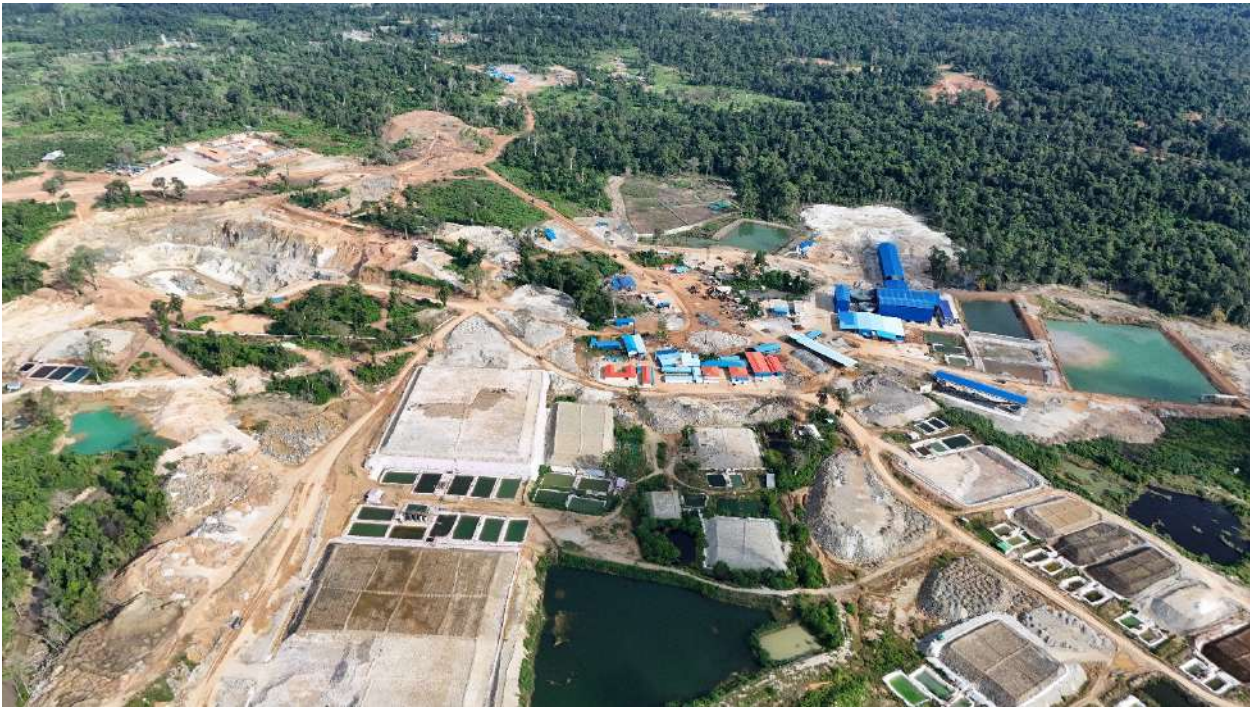
Figure 9b. (cont.). Drone imagery of Late Cheng main mine complex (Summer 2023). In the image below, mine features shown include the open pit mine (red arrow), cyanide leach tanks (blue arrow), cyanide leach fields (heaps)/ponds (yellow arrows), tailing heaps (green arrows), wastewater ponds (orange arrows), and retaining wall for tailings (purple arrow).

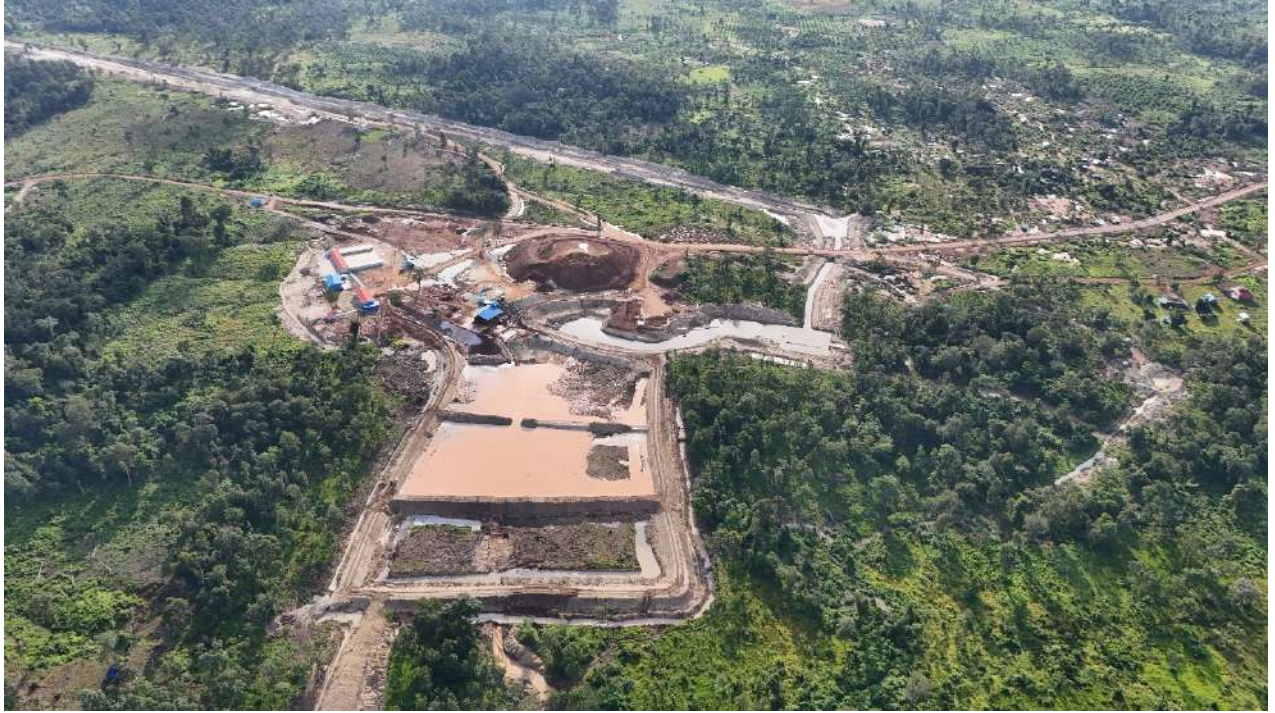
*Figure 10b (cont.). Drone imagery of peripheral mining area south of main mine complex, near O Pha Ao (Summer 2023).*

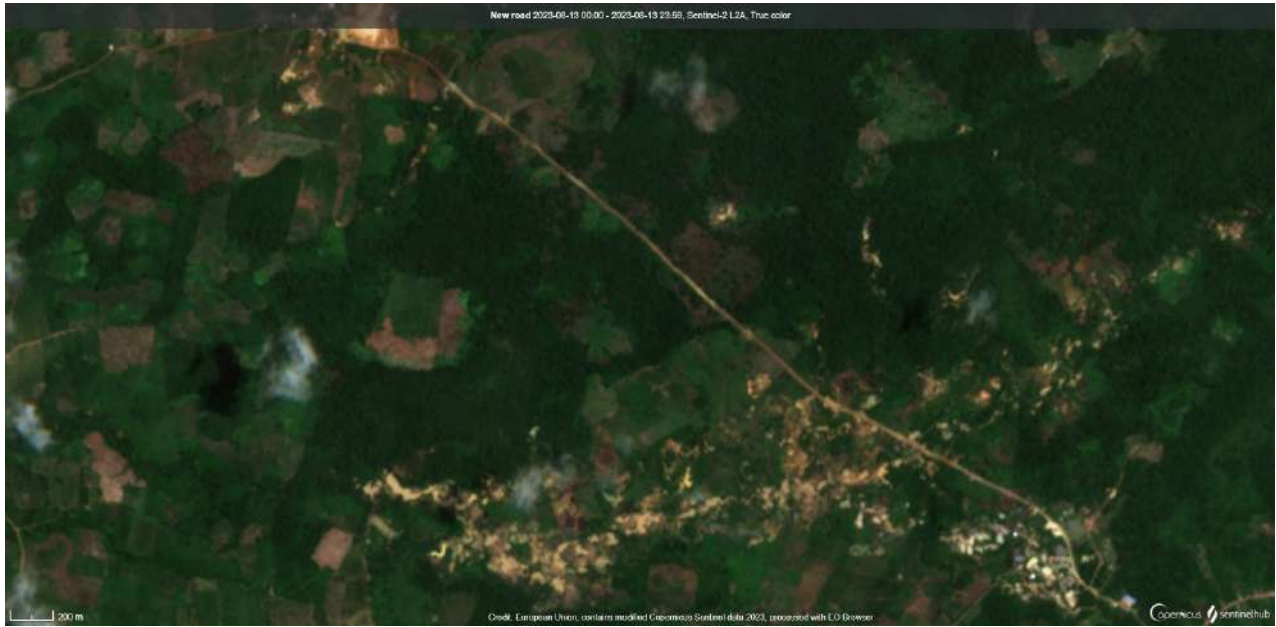
*Figure 12. New road (diagonal line) connecting Phnom Chi artisanal mining area (bottom right of image) with artisanal mining area near O Pha Ao (top left of image). August 13, 2023.*

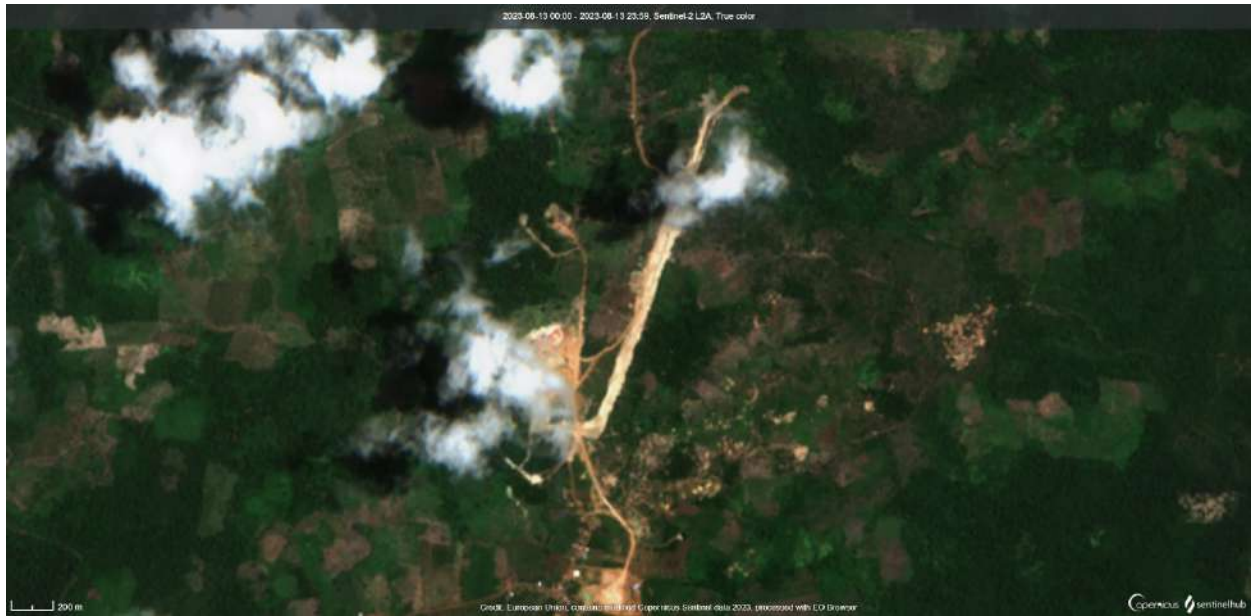
Figure 13a. Straight canal that diverts water from a stream to the mine area at O Pha Ao. Top image is Sentinel imagery providing a complete view of the canal. August 13, 2023.

- Late Cheng’s rapid development includes the construction of one long straight channel that appears to be diverting a stream into one of the open pit mining areas south of Snang An near a location called O Pha Ao by locals (Figure 13a, b, c, d). In addition, another stream appears to be diverted within the main mine complex, including a straight-line channel similar to the one in Figure 13 (Figure 14a, b, c). The rapid expansion of artisanal gold mining (using hydraulic methods) immediately south and west of Snang An Village has taken place in very close proximity to the Porong/Chinit River, and mine tailings can be seen eroding into

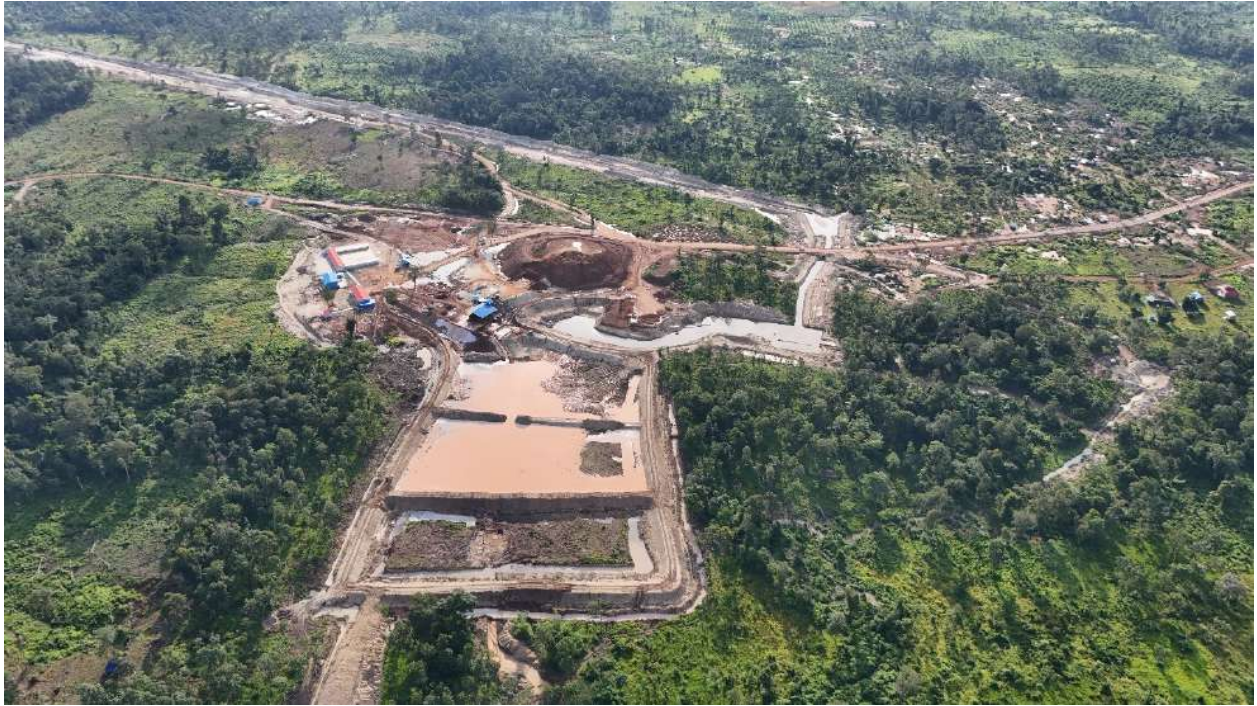
*Figure 13d. Peripheral mining area at O Pha Ao, showing southern terminus of canal that diverts water from the stream at the location shown in 13b. and 13c (August 2023).*

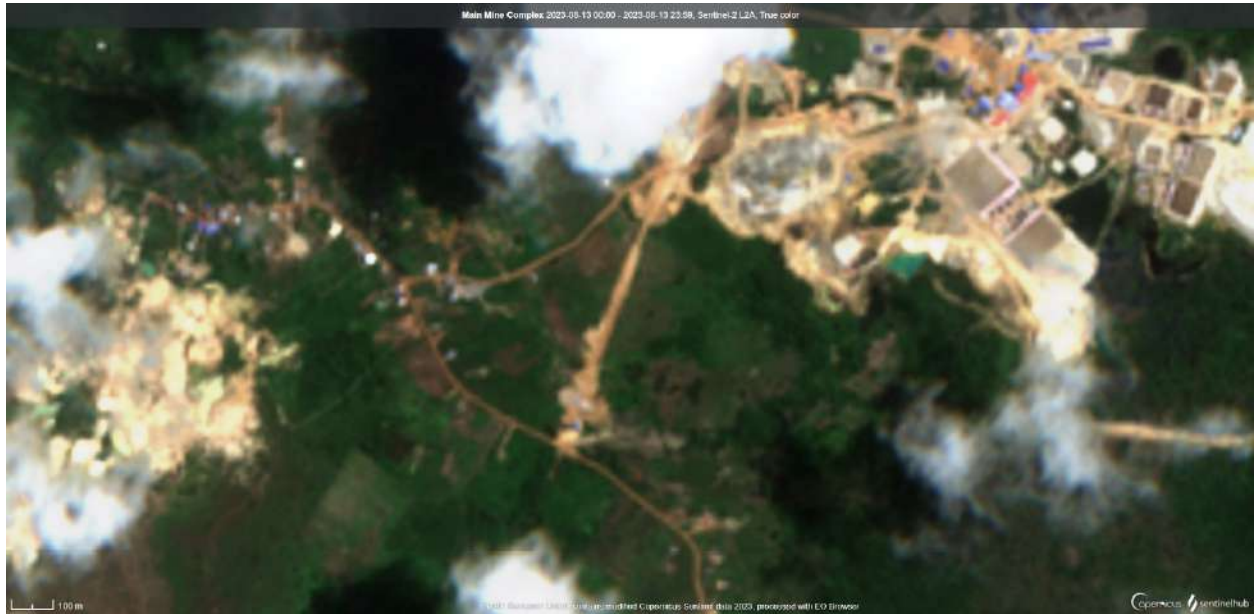
Figure 14a. What appears to be a straight canal that diverts a stream to the open pit mine area at the Late Cheng main mine complex. August 13, 2023.

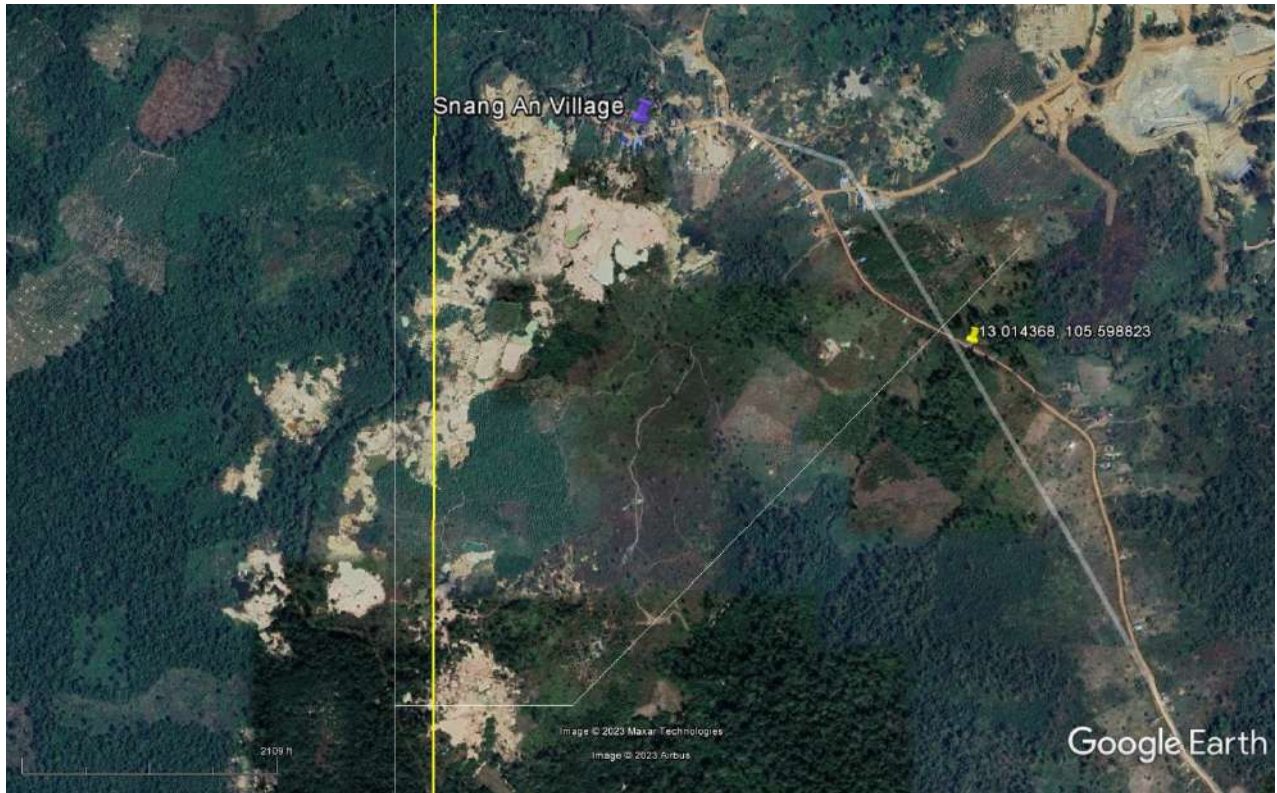
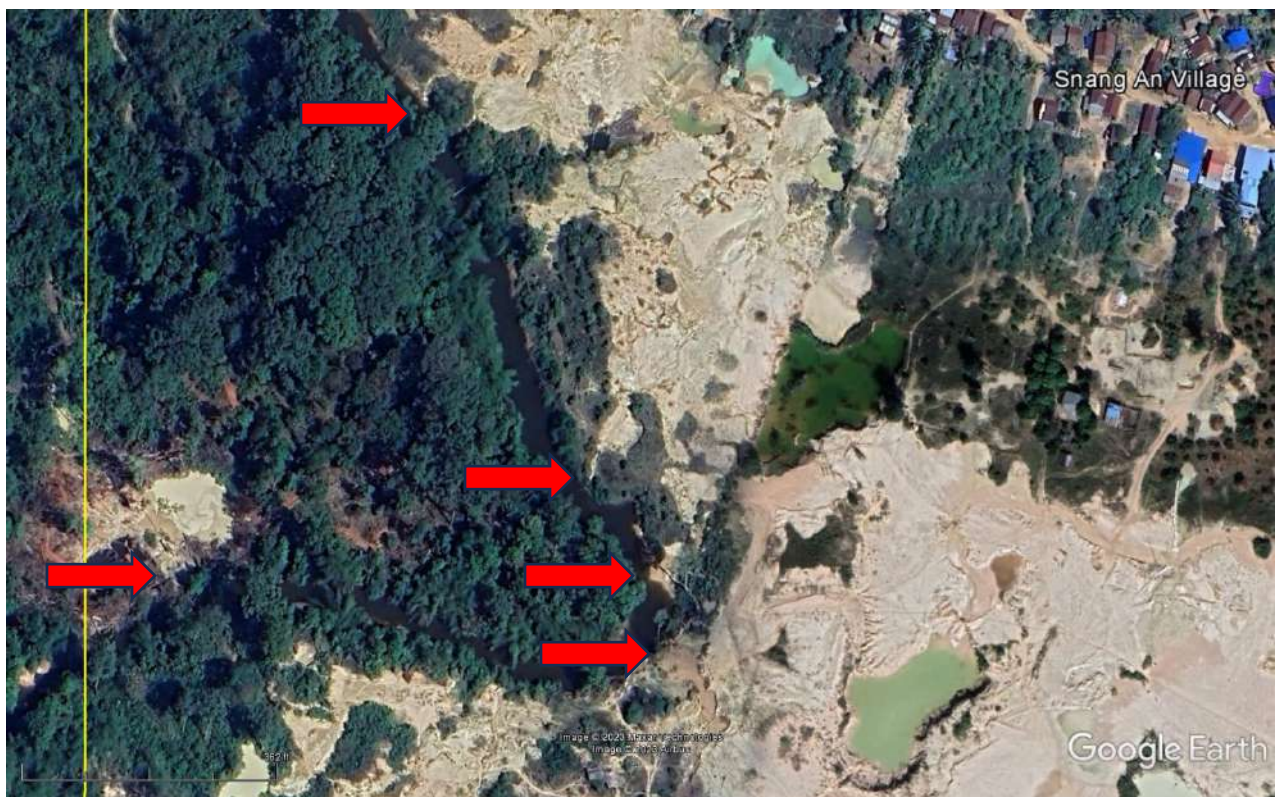
Figure 15. Google Earth image from January 2023 showing artisanal gold mine tailings eroding into the Porong/Chinit River just downstream of Snang An Village. Red arrows show locations where tailings are entering the river.

the river on satellite imagery (Figure 15). In addition, artisanal mining around Phnom Chi has destroyed another tributary stream (Figure 16). Co-opting the streams for these purposes poses an extraordinary threat not only to these streams, but to the entire Porong/Chinit River which receives the flow from these streams, because of the risk of toxic chemical and silt contamination (Figure 17).

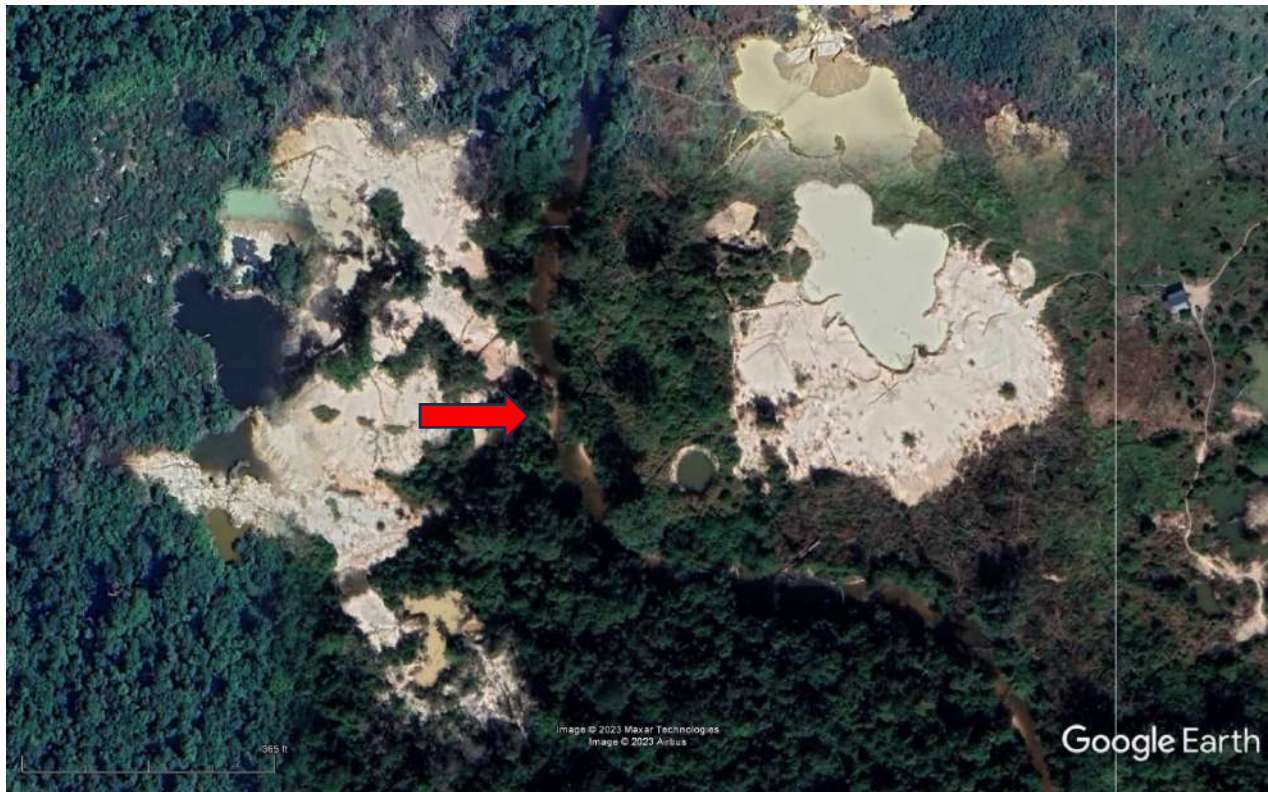
Figure 15 (cont.). Google Earth image from January 2023 showing artisanal gold mine tailings eroding into the Porong/Chinit River just downstream of Snang An Village.

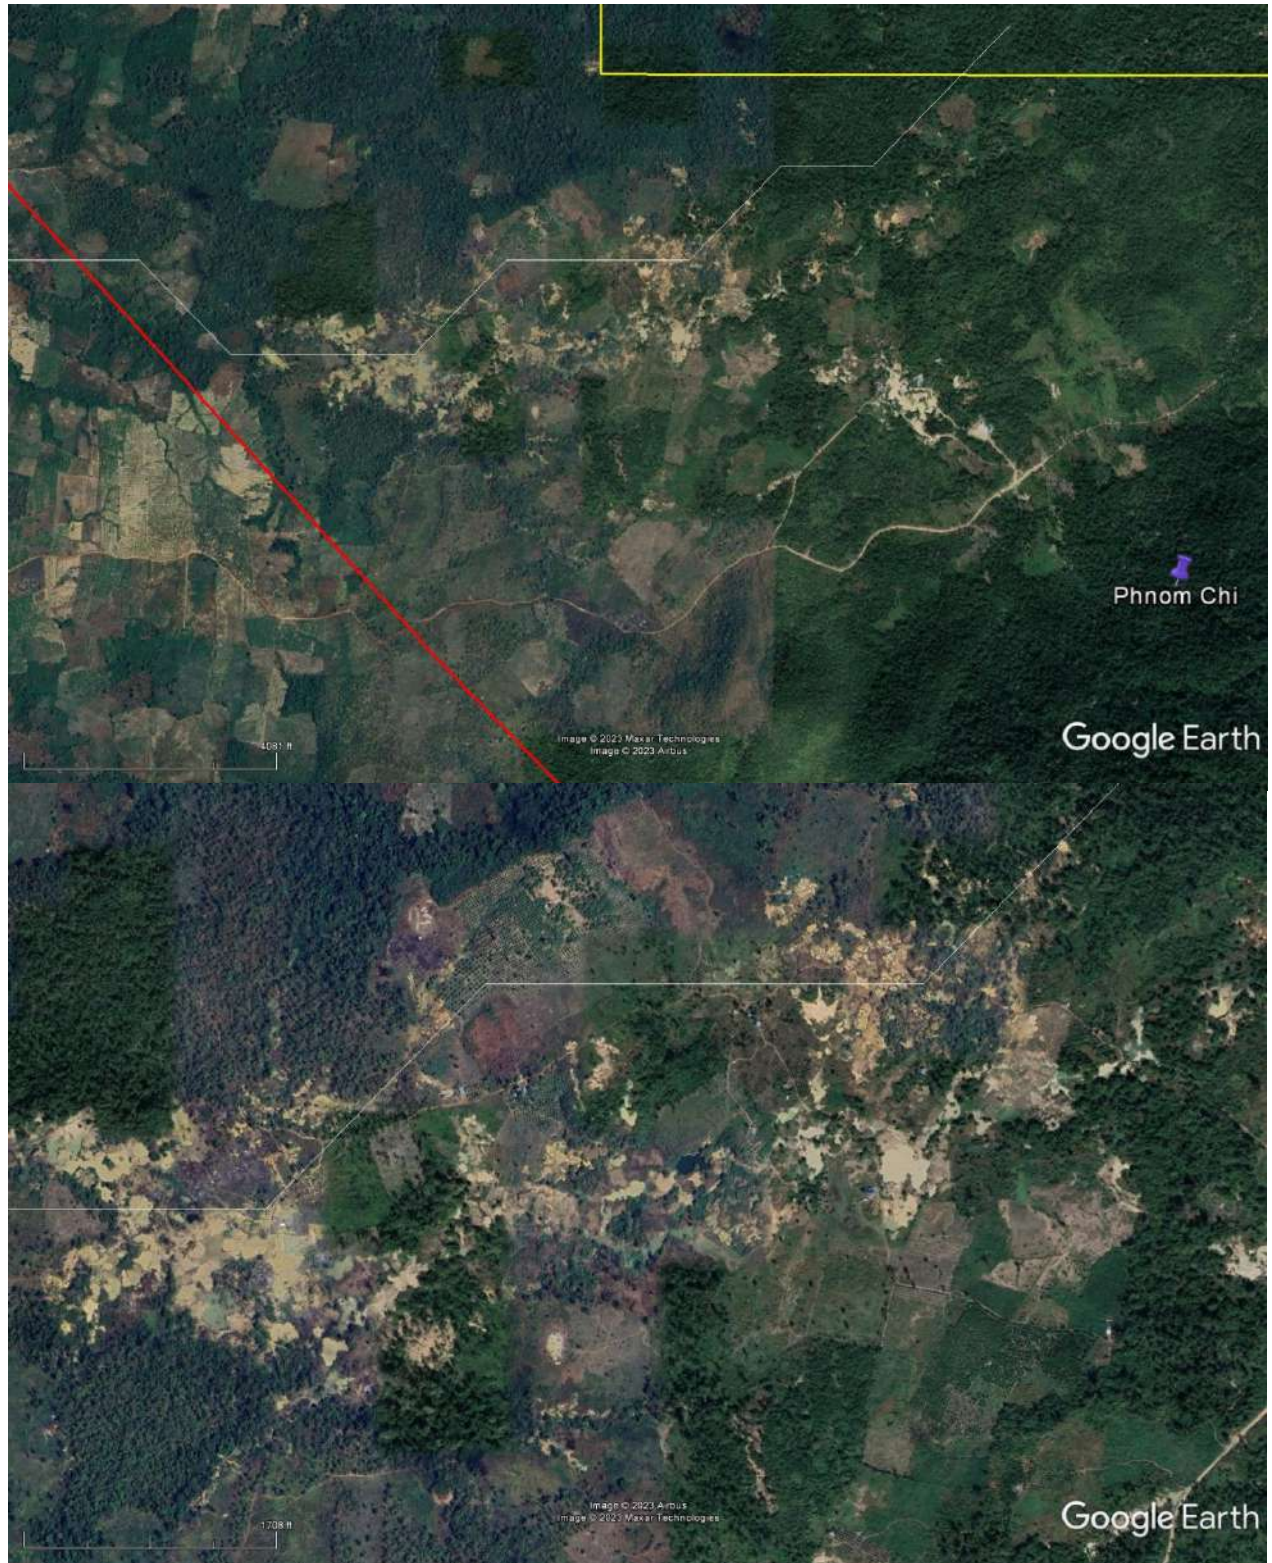
Figure 16. Google Earth image from January 2023 showing artisanal gold mining (hydraulic) damage to a small stream just northwest of Phnom Chi (top image). Bottom image is a closer view of the damage done. Light white line is approximate location of the stream as depicted in the HYDROSHED spatial data base. Yellow line is boundary of Late Cheng concession area. Red line is boundary of PLWS.

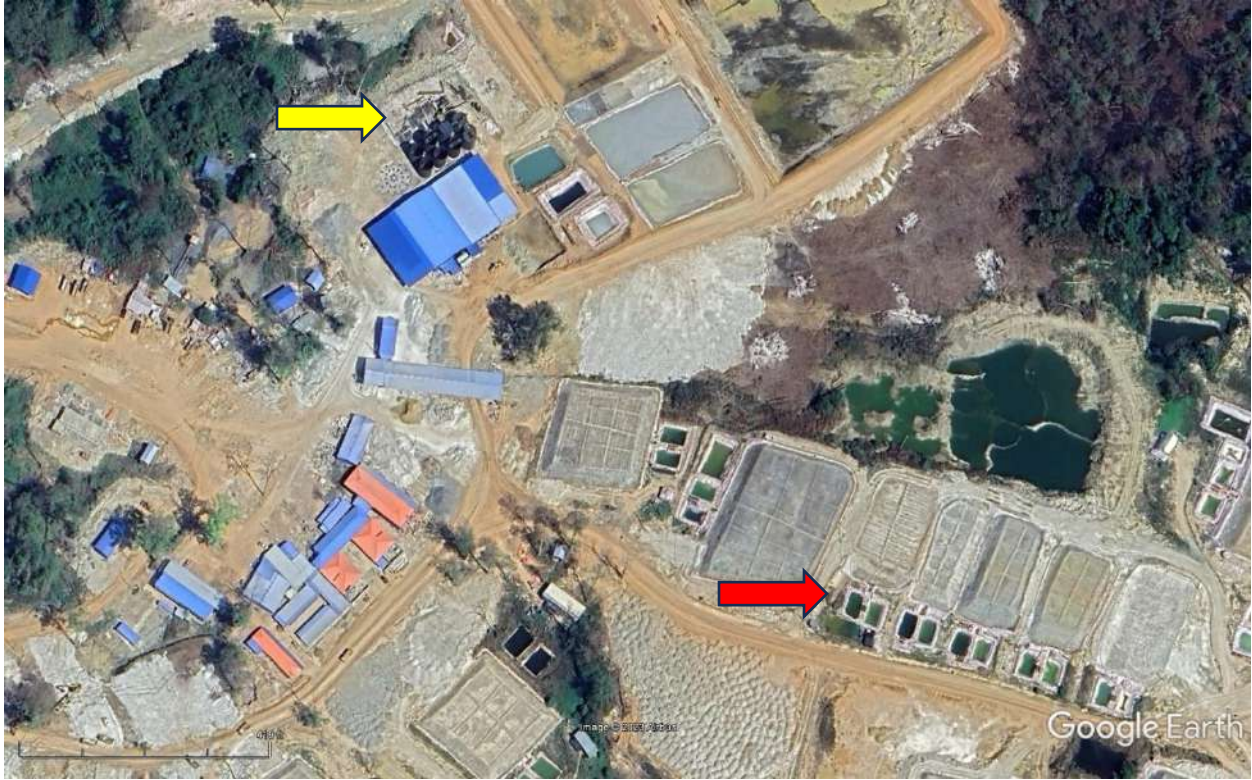
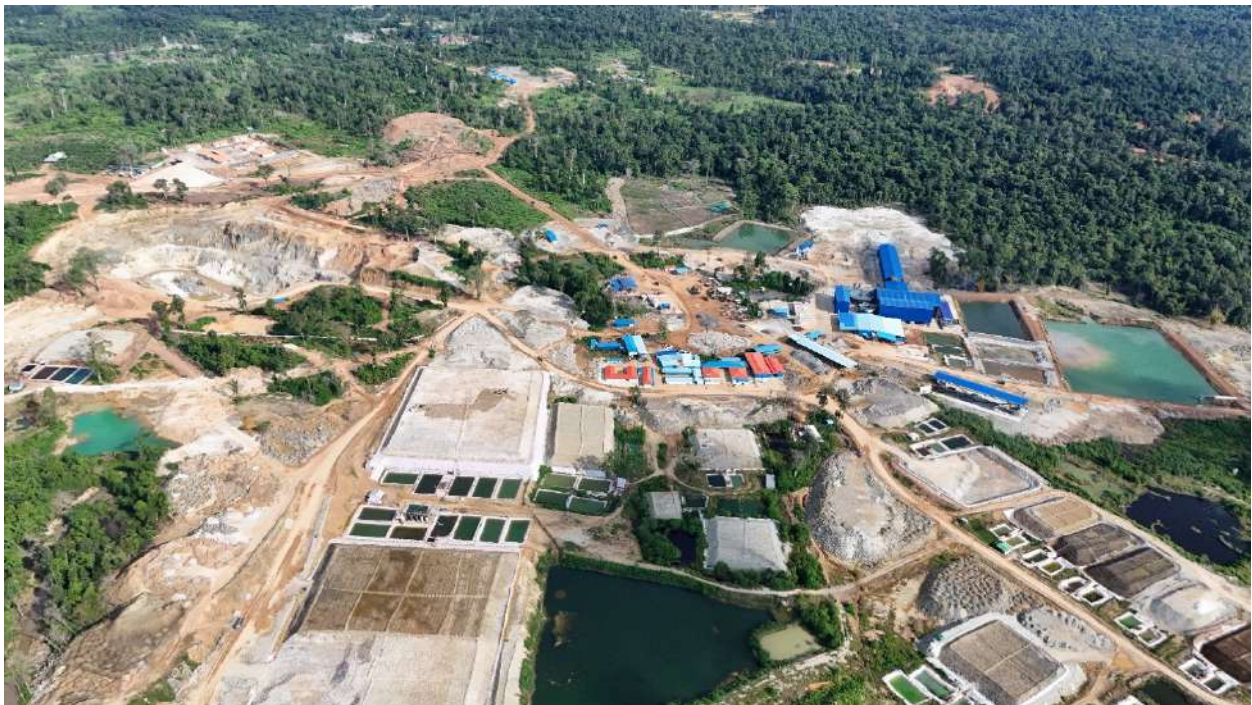
Figure 18a. Evidence of cyanide use at the Late Cheng Mine main mine complex includes leach tanks and leach fields/ponds. Top image is from Google Earth in January 2023 showing both leach tanks (yellow arrow) and leach fields (red arrow). Bottom image is from a drone, taken in Summer 2023, showing this same area, with leach tanks and leach fields/ponds identified with the same color arrows as the top photo.

- It is virtually certain that CYANIDE is being used for gold extraction in the Late Cheng's main mine complex and possibly in the peripheral mining areas within the concession area. This is based on satellite and drone imagery showing the presence of both cyanide leach tanks and cyanide leach fields (heaps)/ponds which are typical of cyanide use (Figure 18a, b), as well as the knowledge that modern commercial gold mining uses cyanide extraction processes almost exclusively.

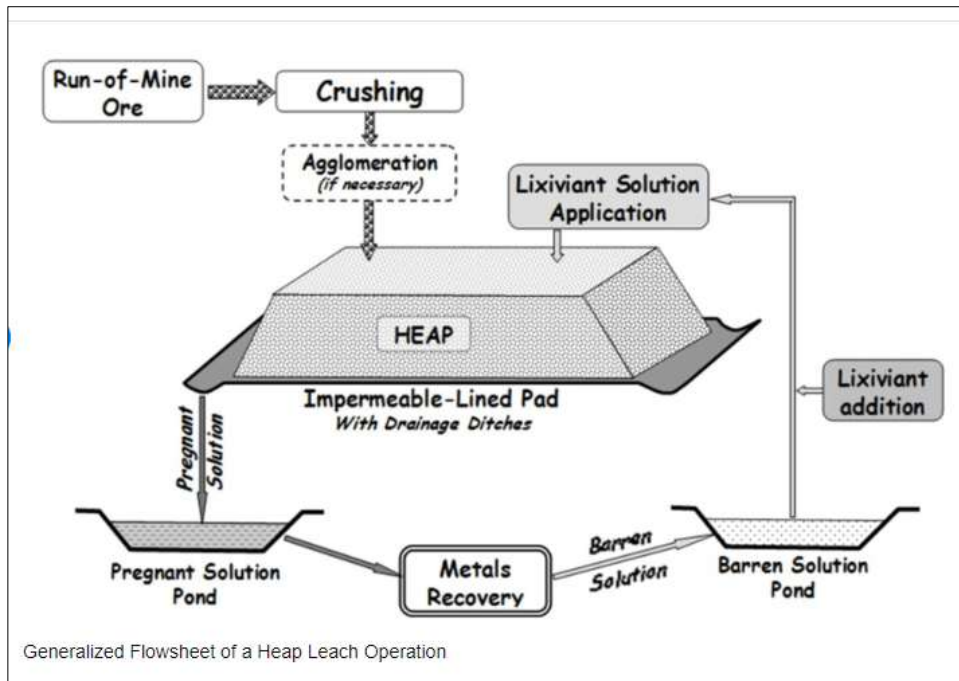
Figure 18b. Schematic drawings of gold mine cyanide operations showing leach tanks and leach fields.

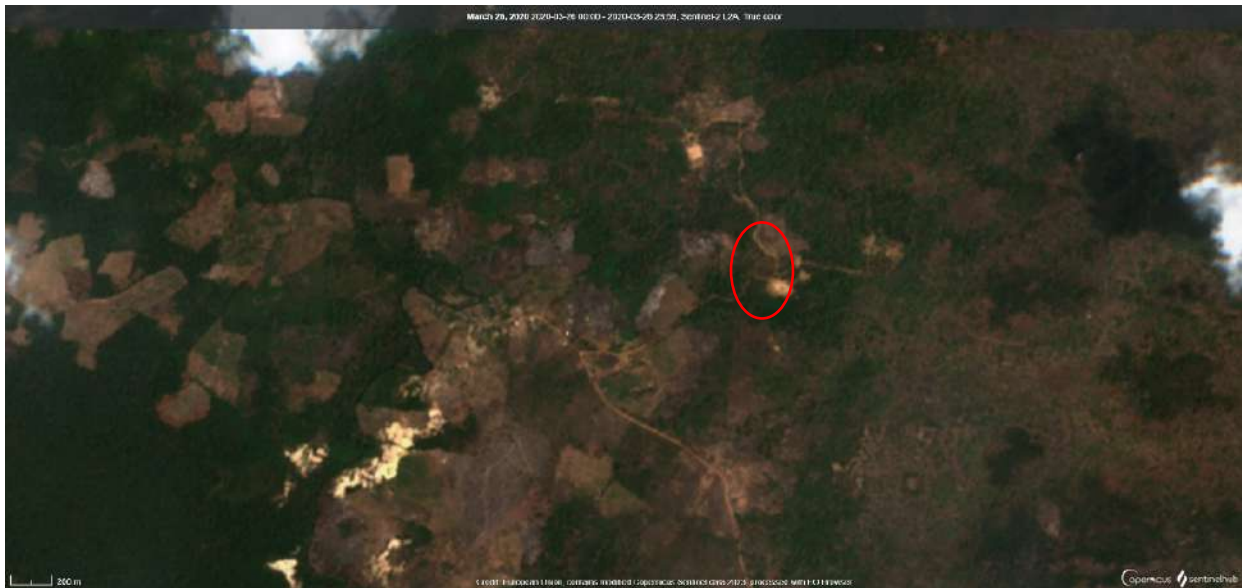
Sentinel imagery from March 26, 2020. Red circle shows remaining evidence of 2018-2019 hard-rock gold mine that was started east of Sngang An Village.

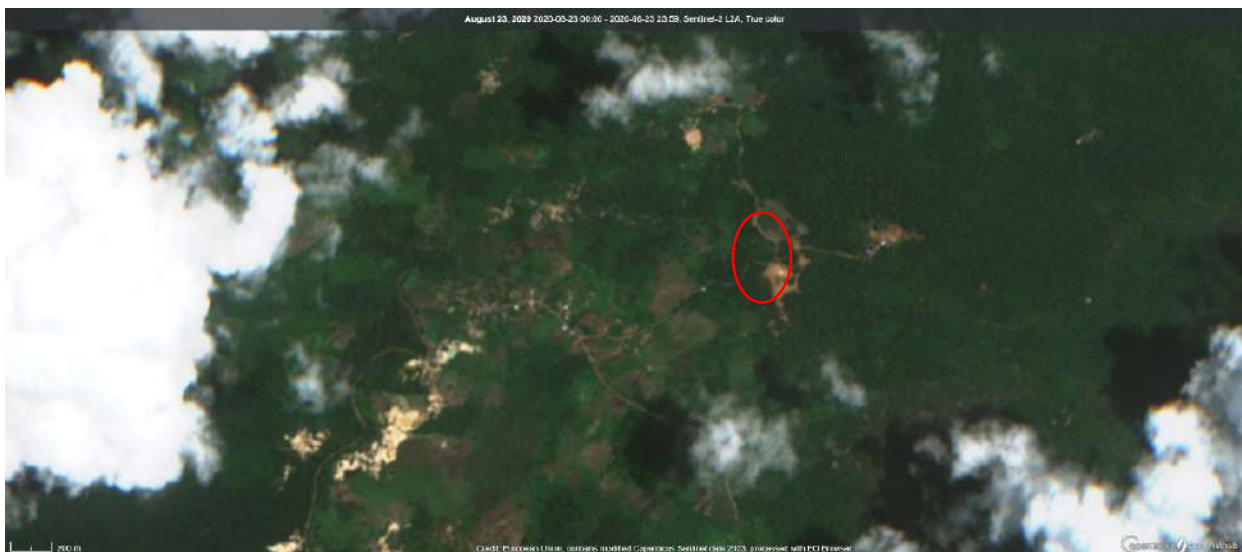
Sentinel imagery from August 23, 2020. Red circle shows first evidence of commercial hard-rock gold mine (Late Cheng Mining Development Company) development at same location as image above.
