# Gold Mining in Prey Lang Wildlife Sanctuary, Cambodia

Evolution from Small-Scale Artisanal to Large-Scale Commercial  
&  
Its Environmental and Human Impacts

Researched and written by: Prey Lang Gold Mining Investigation Team

October 2023

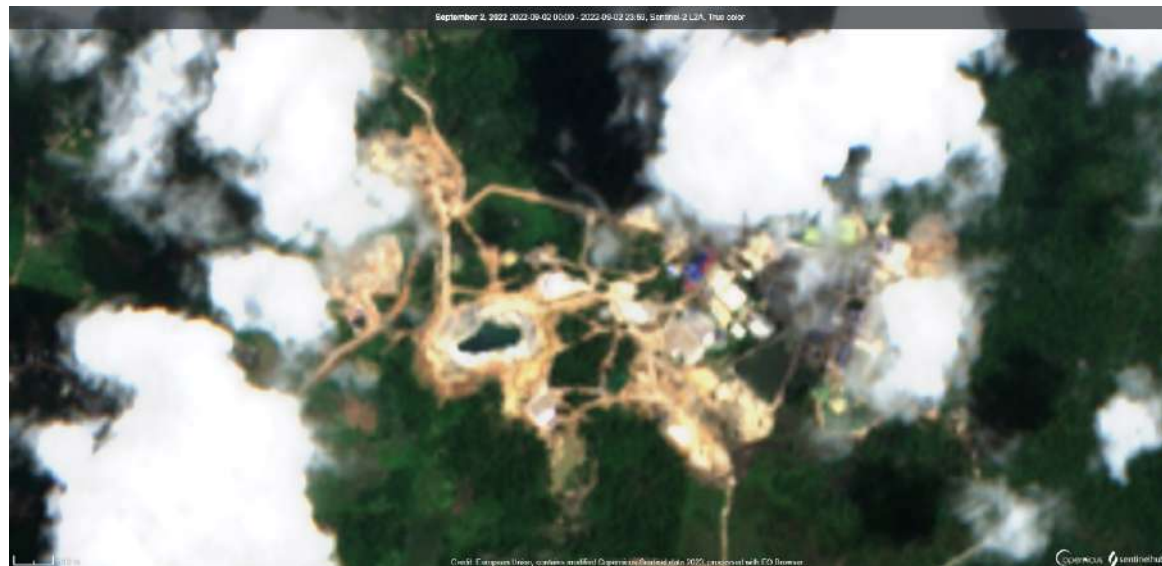
September 2, 2022. Commercial, hard-rock gold mine (Late Cheng Mine) already fully developed and under commercial production. Gold placer mining south of Sngang An Village has been greatly expanded.

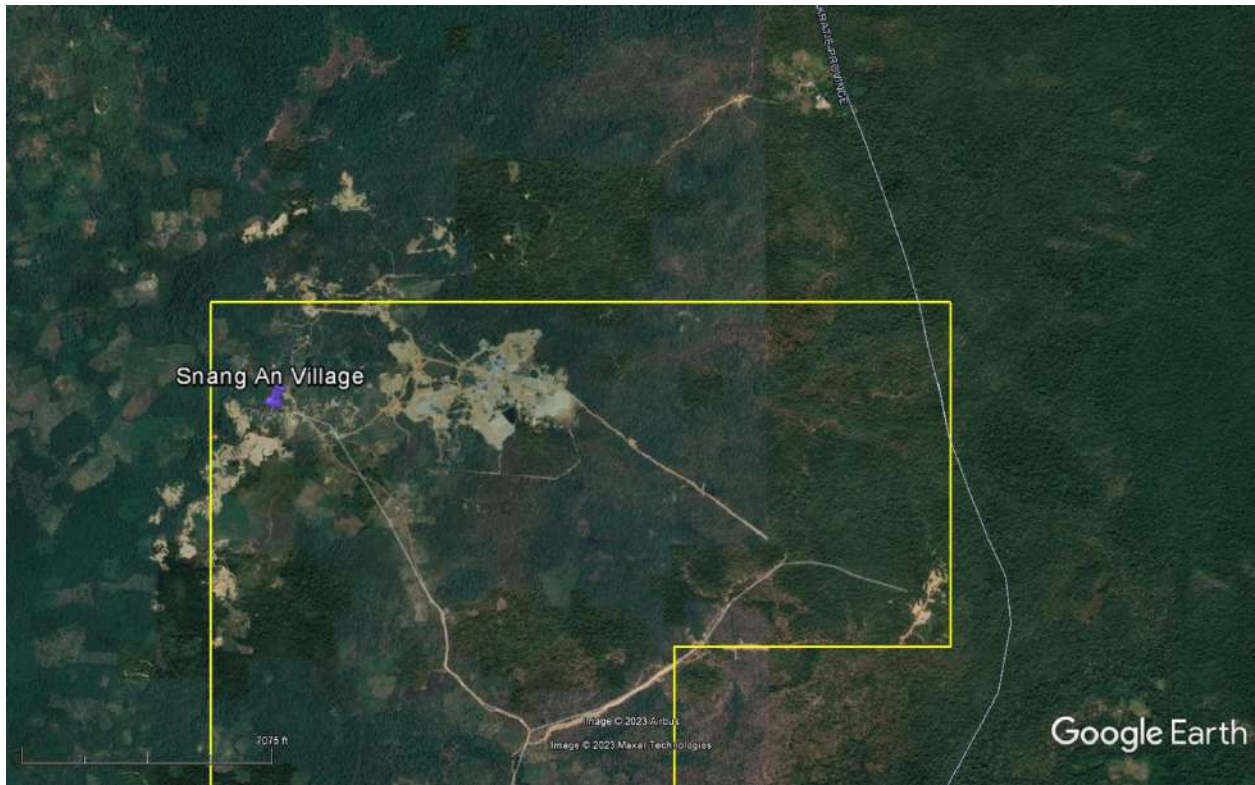
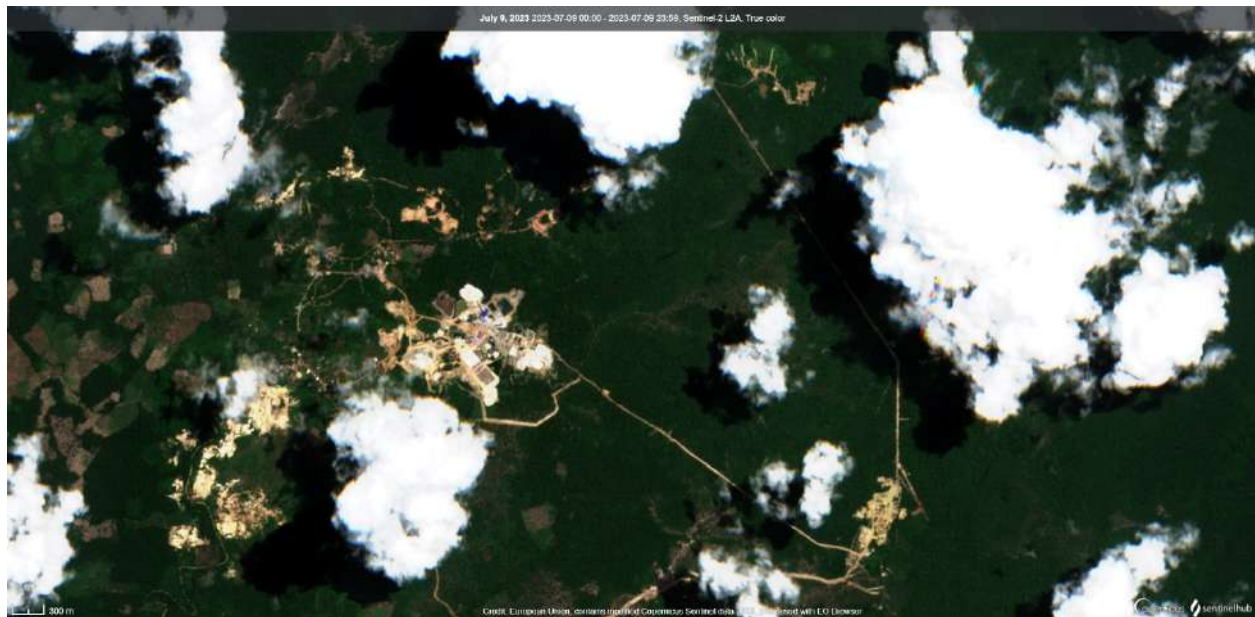
Figure 21. Satellite imagery documenting that Late Cheng’s main mine complex has expanded well beyond the northern boundary of its concession area. Top image is a Google Earth image from January 2023; the concession boundary is the yellow line. Bottom image is a Sentinel image from July 2023, showing further development of mining operations outside the concession boundary, including new development at the “Chinese” hard-rock mine northeast of the Late Cheng main mine complex.

- Late Cheng’s main mine complex has expanded well beyond the northern boundary of its concession area (Figure 21). This development may be associated with another company’s

concession area, but the relationship is unclear. Penalties for such an apparent violation of the concession area boundary would appear to be warranted.

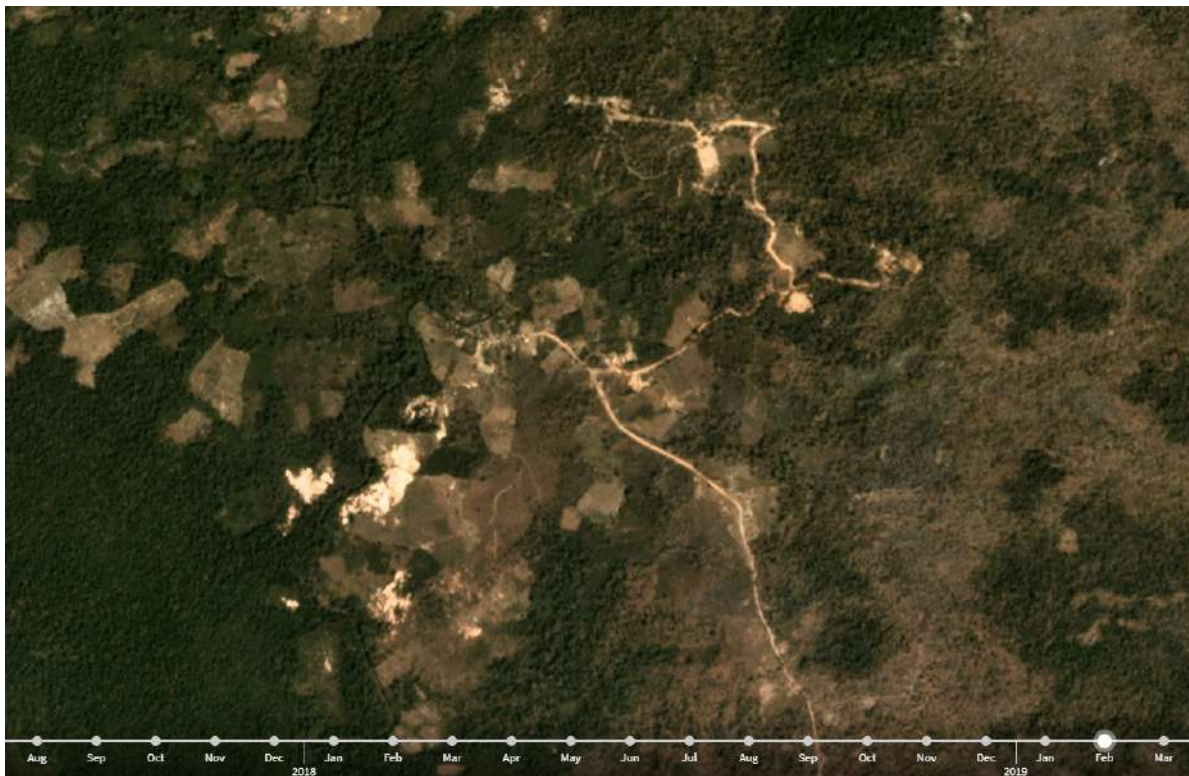
*Section 4a, Figure 4. Extensive mine development February 2019.*

- The new “Chinese” hard-rock gold mine developed very rapidly between December 2018 and February 2019, with continued expansion through April 2019. The following two Planet Explorer images show the rapidity with which the mine was developed. The top image (Section 4a, Figure 3), from December 2018, shows no development. The bottom image (Section 4a, Figure 4), from February 2019, shows the possible leach field, excavated pit, roads and structures.

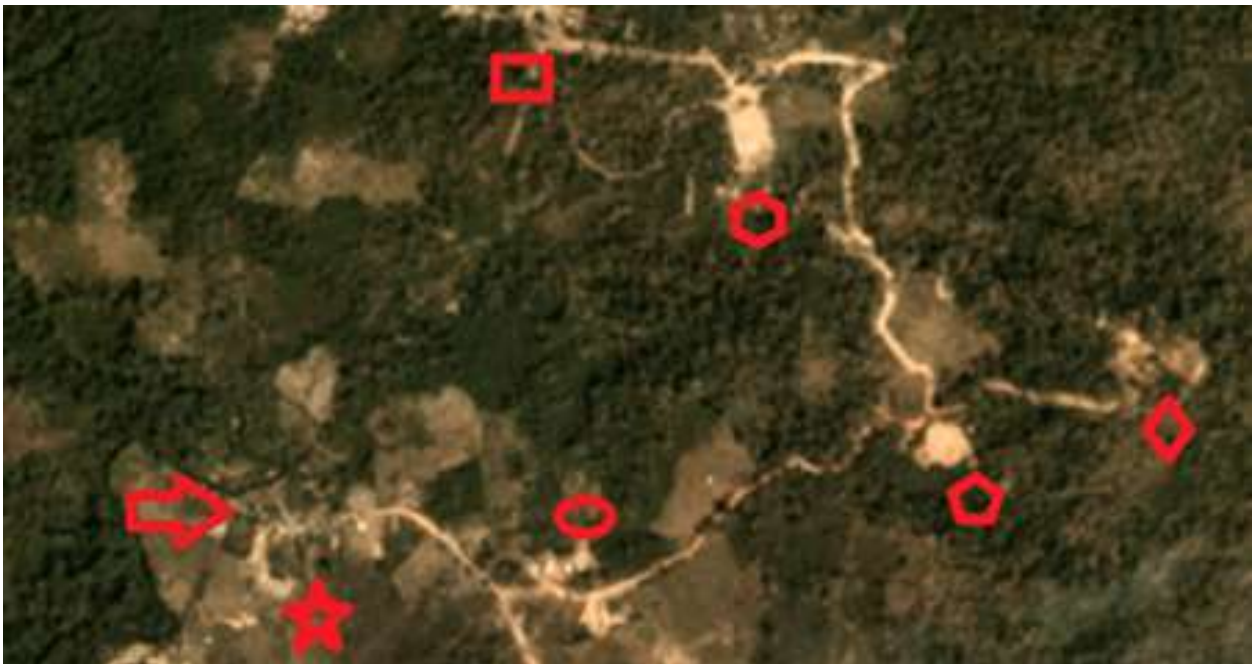
*Section 4a, Figure 5. New “Chinese” hard-rock mining locations Planet Explorer image from February 2019. Arrow points to Snang An Village and bridge over Porong River. Chinese mine locations are: Pentagon is huge pit and associated infrastructure; Diamond is Gold Mining #4; Hexagon is probable cyanide leach field; Rectangle is Gold Mining #5.*

- Huge excavated pit (see photos on next page)
- Associated mine building infrastructure (see photos on next page and second page after this)
- Gold Mining #4 -- Closed shaft mine (see photos on second page after this)
- Probable Cyanide Leach Field (see photos on third page after this)
- Gold Mining #5 -- Closed shaft mine (see photos on fourth page after this).
